HOME SURVEY LEVEL 2

PROPERTY INSPECTED ON 9TH AUGUST 2023
AND REPORT ISSUED ON 11TH AUGUST 2023

WEBSTERS REFERENCE NUMBER **18309**

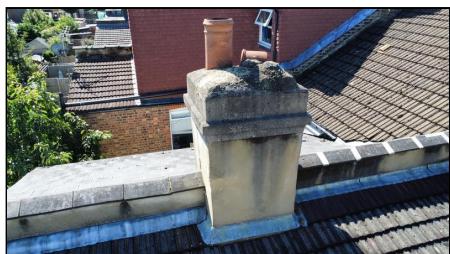
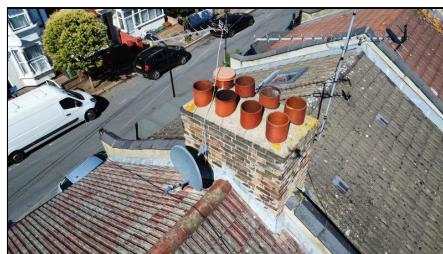
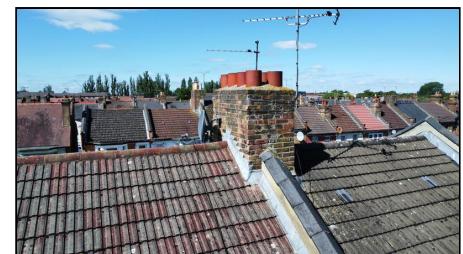
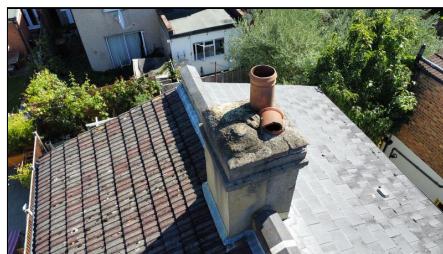
The stacks appear to be in generally satisfactory condition, with no significant defects noted. Normal maintenance will be required.

The condition of the front stack is consistent with age, with some weathering evident to the brickwork and mortar. There is also minor cracking to the flaunching of the front chimney stack which will need to be

The rear stack has been capped and covered in rendering to which no significant defects were noted. There is staining to the render which is likely to be due to inadequate drip details around the top of the stack. This is not considered to be of significance. The rendering may conceal defective brickwork and pointing and should you ever wish to remove the rendering the need for repairs should be expected.

There is cracking to the neighbours side of the rear stack. One of the pots to the neighbours side has been capped. Part of the pot itself has been laid over the top of the open flue and we are unable to confirm if this is adequately secured in position. This should be checked when undergoing any works.

Repairs to the chimney are not urgently required but should be budgeted for in the medium term.

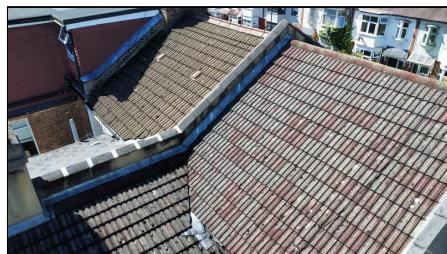
Image - 10

There is very minor cracking to the render, although this is not considered to be of significance.

The coping tiles are uneven in places and it appears the mortar to some of the tiles has shrunk. There is also minor damage to one of the tiles. During future maintenance, the tiles are likely to require repointing.

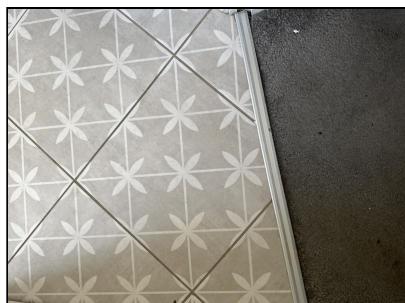
Image - 29

The floors are in generally satisfactory condition being firm and level where accessible.

The timber floors were found to have some degree of spring and unevenness, but with no signs of significant deflection or distortion. This is not considered unusual for a property of this age and type. When coverings are removed/replaced, loose or defective boards can be attended to.
