## HOME SURVEY LEVEL 3

PROPERTY INSPECTED ON 6TH SEPTEMBER 2023  
AND REPORT ISSUED ON 11TH SEPTEMBER 2023

WEBSTERS REFERENCE NUMBER **18491**

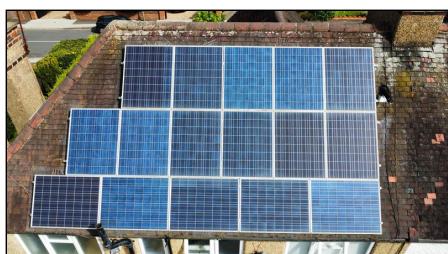
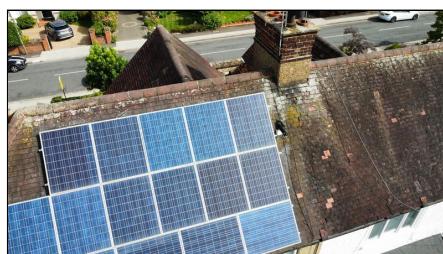
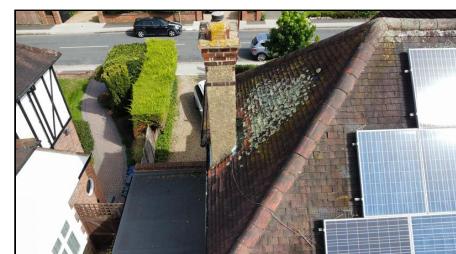
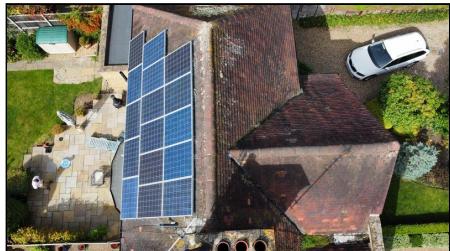
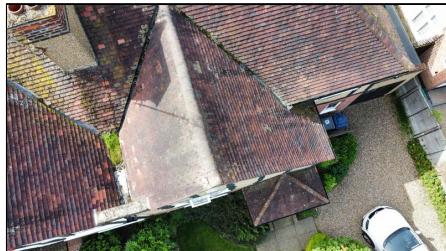
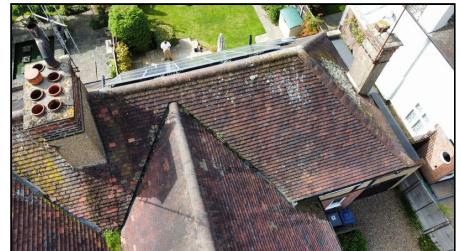
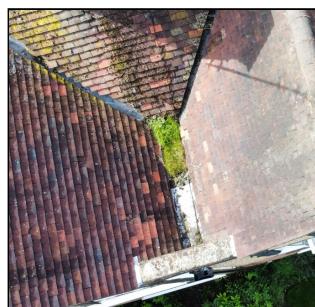
Open valleys, which are formed at the intersection between two sloping roof surfaces, were viewed with the aid of a drone only and appeared to be lined with lead but where seen to be congested.

The main pitched roof appears generally even, with no indication of significant sagging or distortion. The roof covering appears to be in generally satisfactory condition for its age and with no significant defects noted. The rear roof slope however is of course largely covered in the solar panels. Subject to normal ongoing maintenance, the covering should remain serviceable for some years.

There are a number of tiles that appear to have been replaced to the front and rear as they are much cleaner in appearance. Some tiles however to both slopes are dislodged, including right on the rear party wall between the two properties. Clarification should be sought legally with regards to ownership and responsibility. A roofer will be required to fix the tiles to both slopes in any event.

The solar panel installation will have added weight to the original covering and may have required strengthening. No evidence of significant deflection was observed but additional strengthening might be required in the future.

Slight deflection of both roof slopes can be seen over the party walls. This is often found with houses of this age and is not considered to be significant.

You should instruct a reputable roofing contractor to make a closer inspection to provide a quote for the necessary repairs.

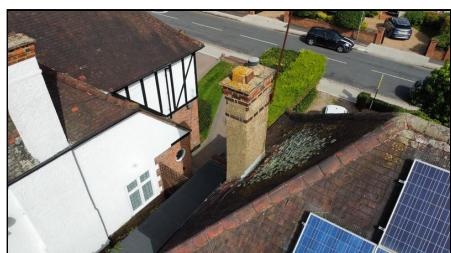
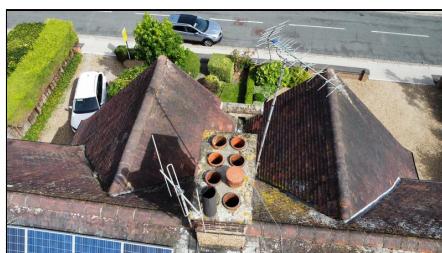
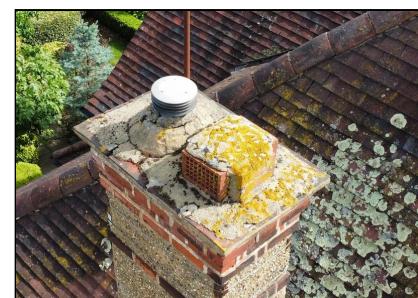
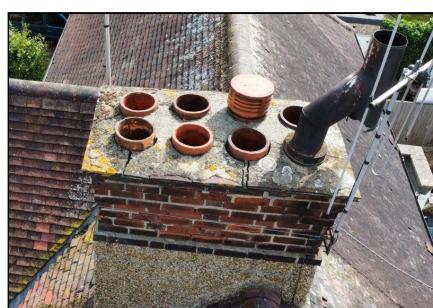
The chimney stacks are of masonry construction, mostly rendered above the roofline with metal flashings at the stack/roof abutment to prevent damp penetration occurring internally to the smaller stack. No flashings were visible to the central main stack.

The brickwork and pointing to the chimneys is becoming slightly weathered. Repointing is required to prevent further deterioration and to maintain the long-term stability of the stacks. Any badly weathered bricks will need to be cut out and replaced.

The cement mortar flaunching to the top of the stacks appears to be cracked and damaged, which will result in rainwater penetration to the brickwork and further deterioration in the future.

Repairs to the chimney stacks are not urgently required but should be budgeted for in the medium term.

You should instruct a reputable roofing contractor to make a closer inspection to provide a quote for the necessary repairs.

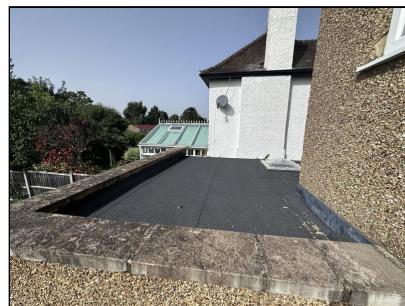
Image - 15

The parapets appear to be in generally satisfactory condition given their likely age and exposed position. Normal maintenance will be required.

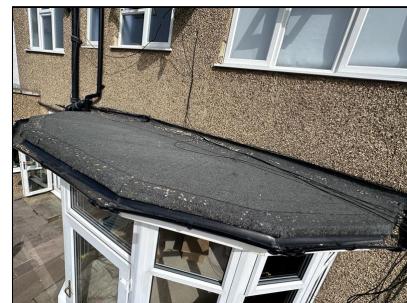
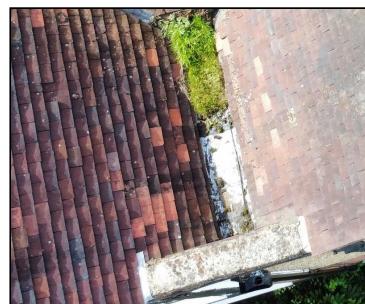
These appear to be in generally serviceable condition with no evidence of significant defects although some ongoing maintenance will be required. It was not raining at the time of inspection and, therefore, it was not possible to confirm whether the rainwater goods are watertight.

Leaking rainwater disposal systems can lead to penetrating dampness and deterioration of the building. You should ensure that rainwater gutters and downpipes are regularly cleaned and maintained.

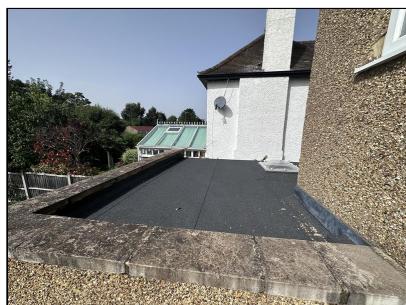
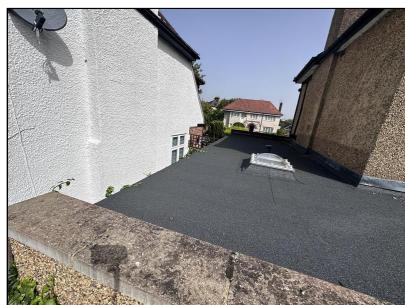
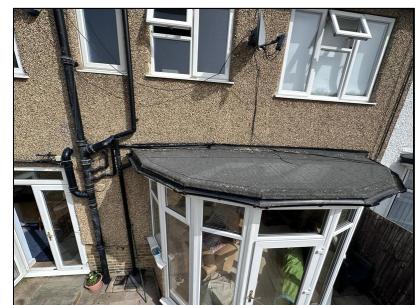
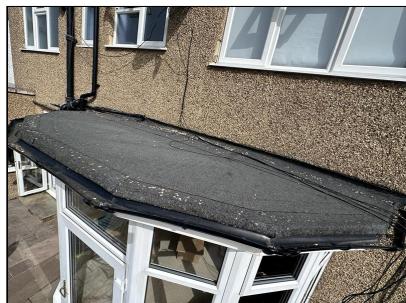
The pitched roof is covered in plain tiles, like the main roof.

The other two roofs are covered in mineral felt.

The roof coverings appear to be in generally satisfactory condition for their ages and with no significant defects noted. Subject to normal ongoing maintenance, the coverings should remain serviceable for some years.

The flat roofs are covered with mineral felt. This type of covering has a limited lifespan and ongoing repair maintenance and eventual replacement must be anticipated. Experience shows that leaks can manifest themselves unexpectedly. Repair works may prove to be expensive as water ingress may cause collateral damage to structural elements and decorative finishings.

There is a skylight window within the flat roof above the extension. The skylight window where it intersects the flat roof is considered to be a weak point and the flashings surrounding it may fail allowing damp penetration to occur. No evidence of such a failure was noted but leaks can occur unexpectedly. Repair works may prove to be expensive as water ingress may cause consequential damage to structural elements and decorative finishings.

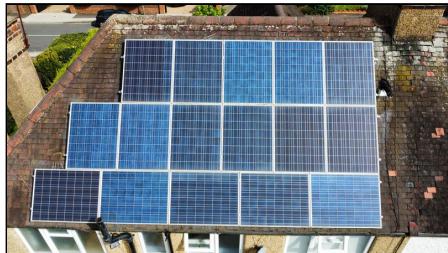
Image - 141

The property benefits from a solar panel system with a vast number of solar panels on the rear roof slope with the associated inverter base unit within the roof void. It is understood the solar panel system is owned outright and not lease. Confirmation should be sought from your legal advisor.
