HOME SURVEY LEVEL 2

PROPERTY INSPECTED ON 9TH AUGUST 2023
AND REPORT ISSUED ON 11TH AUGUST 2023

WEBSTERS REFERENCE NUMBER **18309**

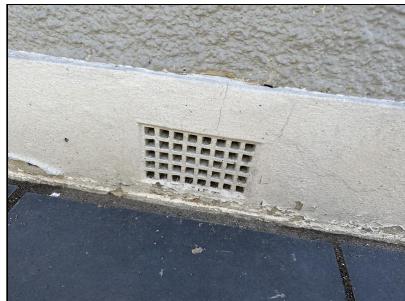
Image - 19

Suspended ground floors require ventilation to prevent an accumulation of moisture within the floor voids. There seems to be an adequate number of vents of sufficient size to provide satisfactory ventilation under the floors.

It is possible that dampness and condensation could cause timber decay to the sub floor.

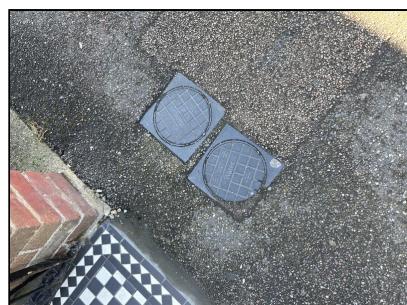
Image - 39

The outside stop tap appeared to be located in the front pavement.

Internal pipework, where visible, is of copper.
