## HOME SURVEY LEVEL 3

PROPERTY INSPECTED ON 6TH SEPTEMBER 2023  
AND REPORT ISSUED ON 11TH SEPTEMBER 2023

WEBSTERS REFERENCE NUMBER **18491**

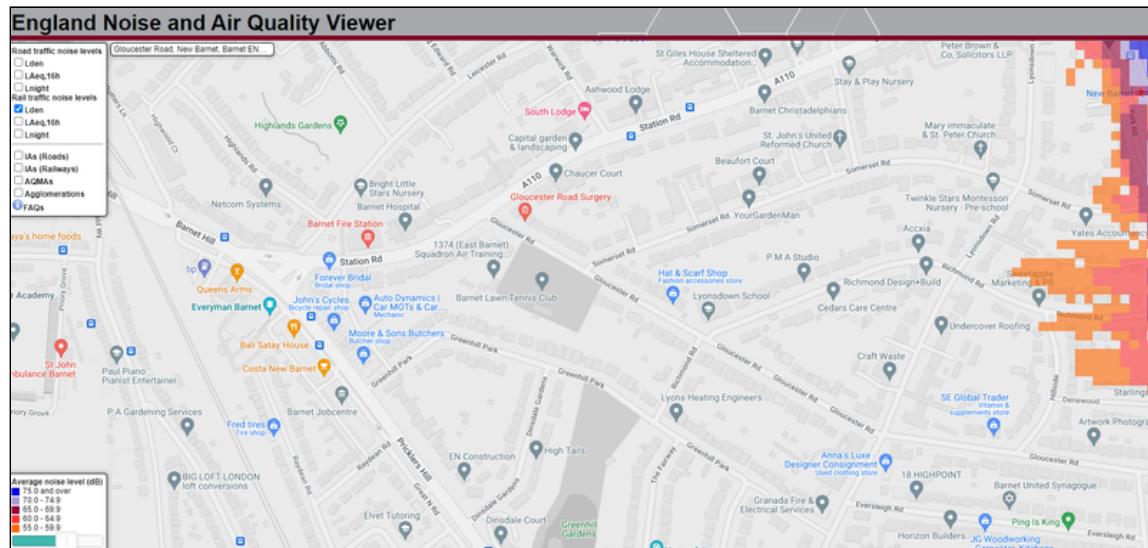
Image - 143

The information is correct at the point of issue according to Environmental consultants Extrium. Please be aware that noise levels can of course vary over time and even through an individual day. They can be impacted by recent or proposed developments where applicable such as roadworks and new rail or tube lines.
